TEXA	TEST REPORT	
	PROJECT	DESCRIPTION
	TEST TYPE	CODE
	Konfort 700	
	Contamination test with Konfort 780R

The purpose of the test is to evaluate the contamination level of the refrigerant in the two tanks of a Konfort 780R after a series of alternated recycles.

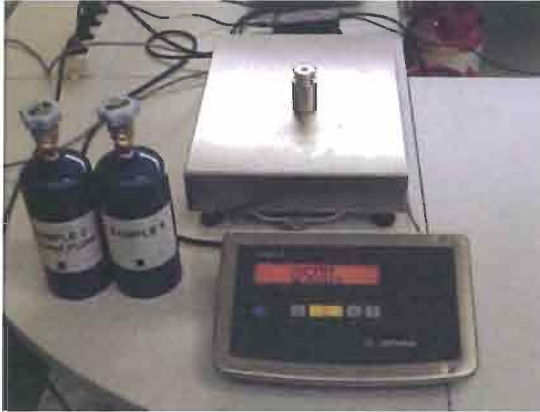
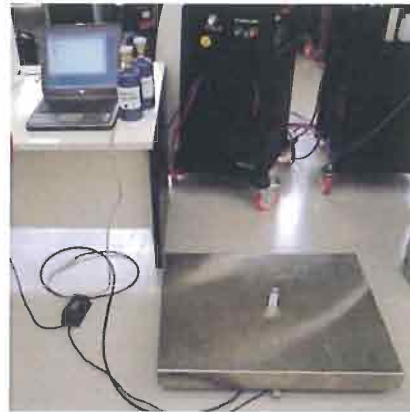
- Scale measurement check 500g sample weight

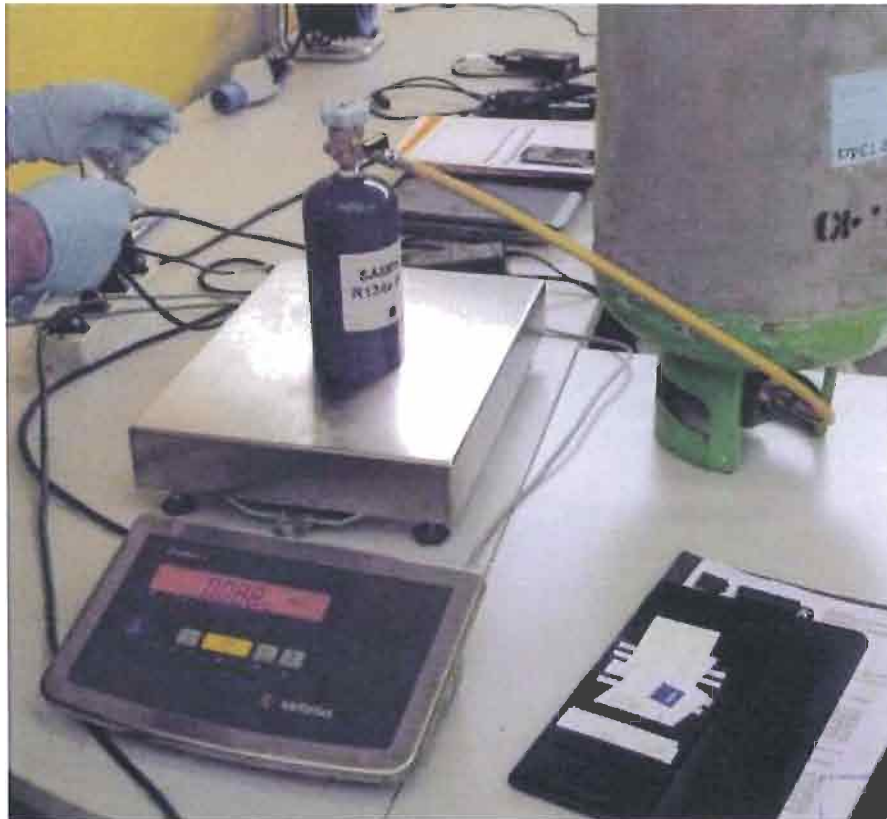
- Extraction of pure gas samples and approval of the gas cylinders by the TÜV Rheinland Italia inspector:

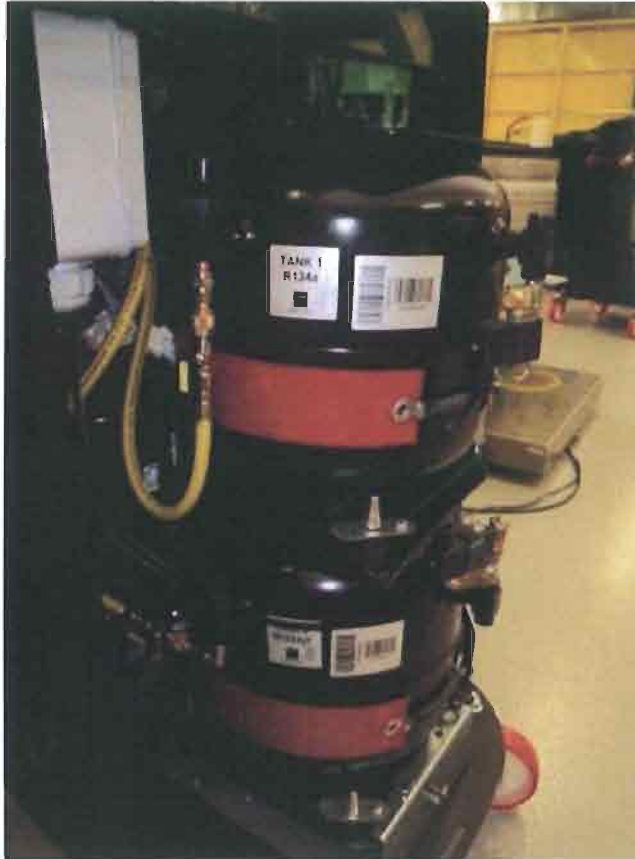
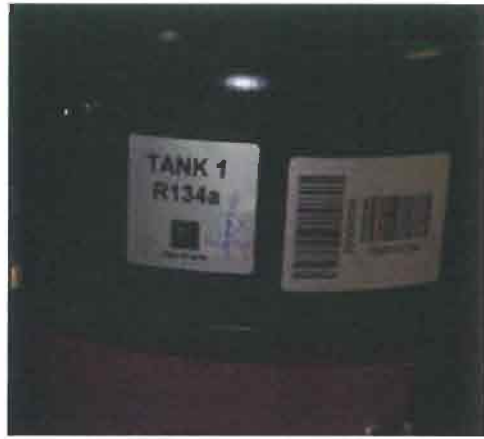
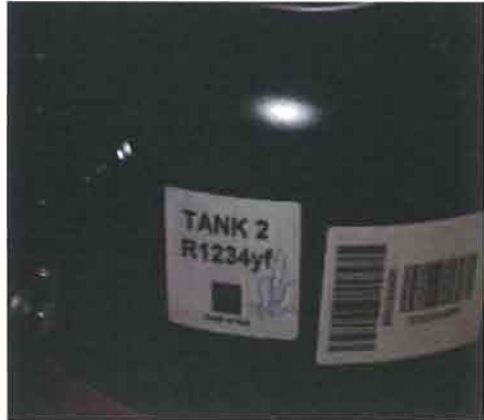
- Approval of the Konfort 780R tanks by the TÜV Rheinland Italia inspector:

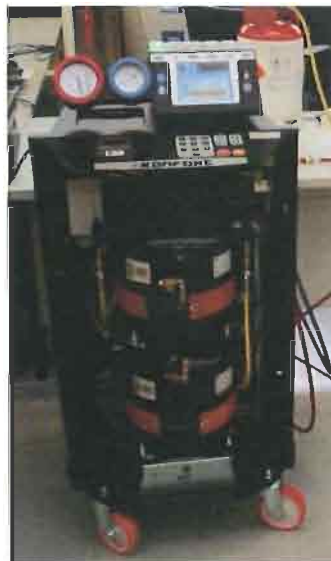
- The Konfort K780R charging station was prepared by emptying the two tanks and creating vacuum throughout the entire system, tanks and compressor included, for 3 hours.

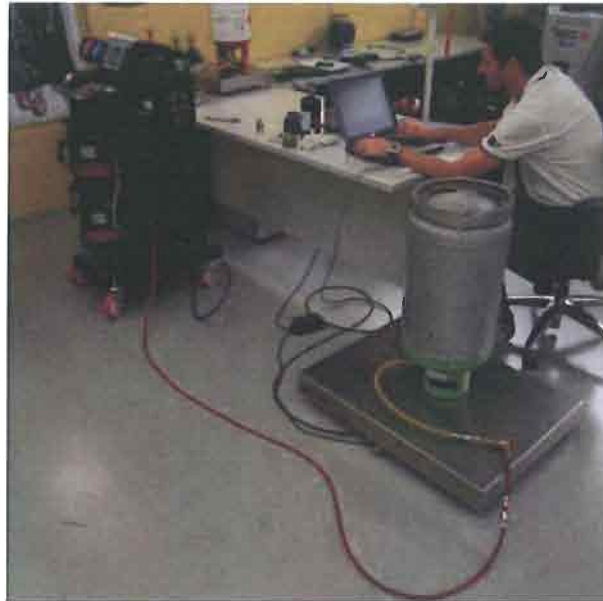
- n° 10 recycles of 400 g of R134a refrigerant

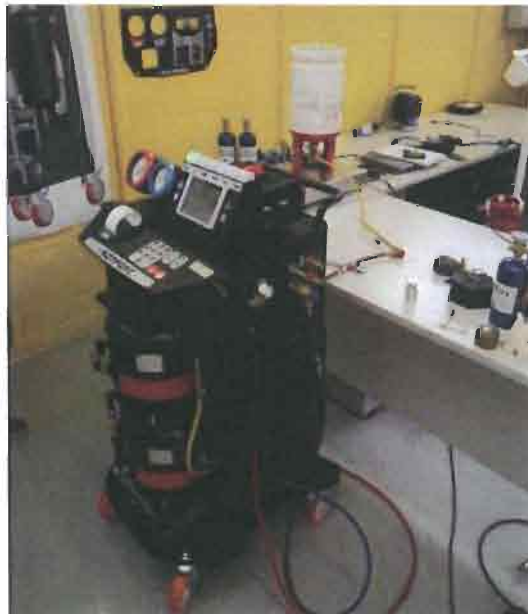
- n° 10 recycles of approximately 400 g of R1234yf refrigerant.

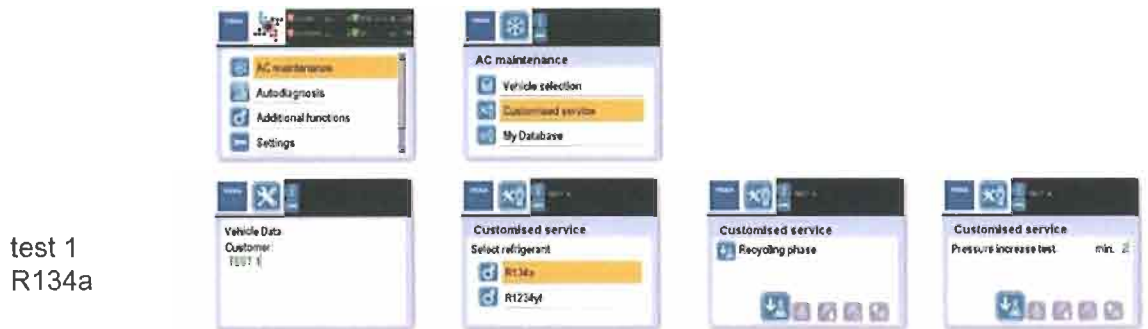
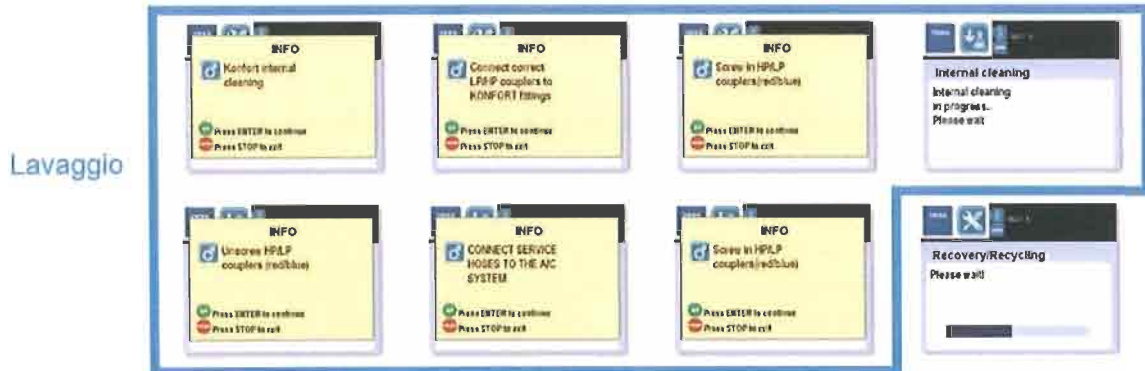
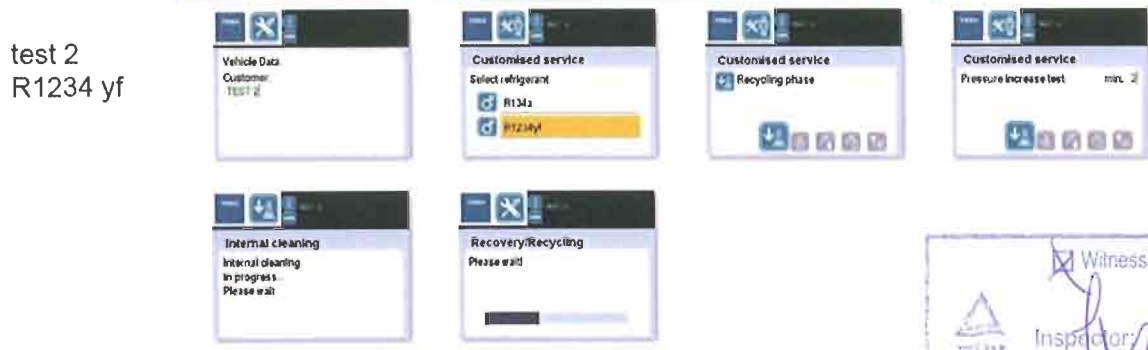
Konfort 780R display screenshots that represent the cycles that were carried out:

recycle	Quantity [g]	
	R134a	R1234yf
1	413	-
2	-	409
3	416	-
4	-	493
5	401	-
6	-	418
7	424	-
8	-	407
9	425	-
10	-	403
11	440	-
12	-	456
13	411	-
14	-	398
15	412	-
16	-	390
17	419	-
18	-	403
19	408	-
20	-	416

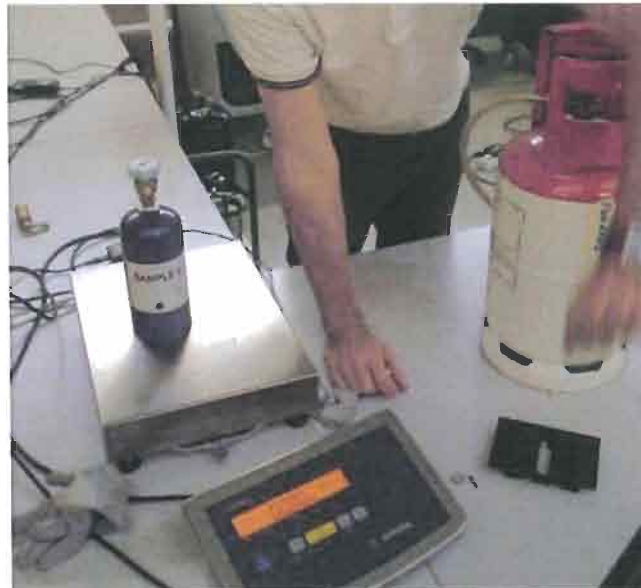
➤ Scale reset, R134a gas extraction from the Konfort K780R tanks

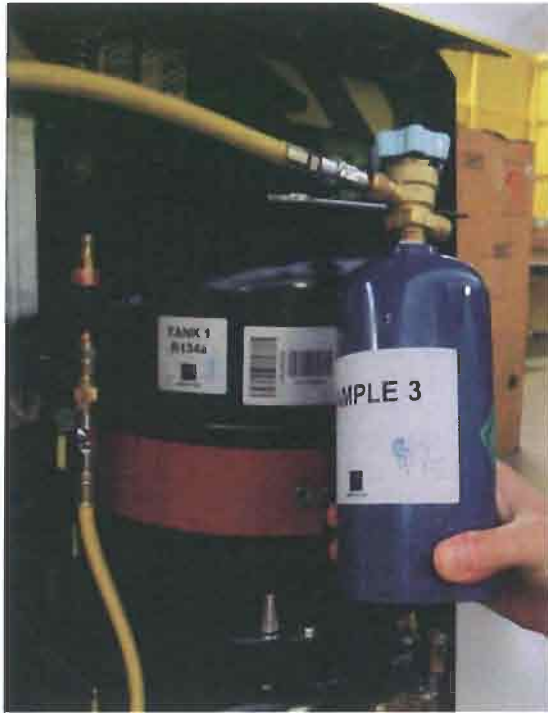
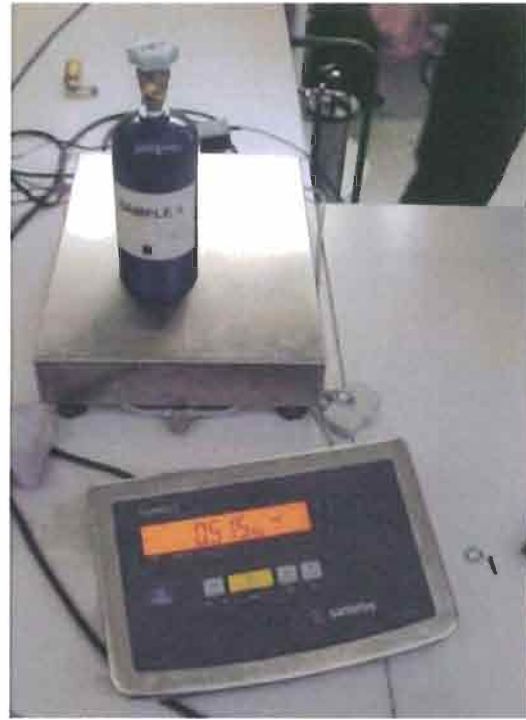
515 kg of R134a was extracted from Sample 3.

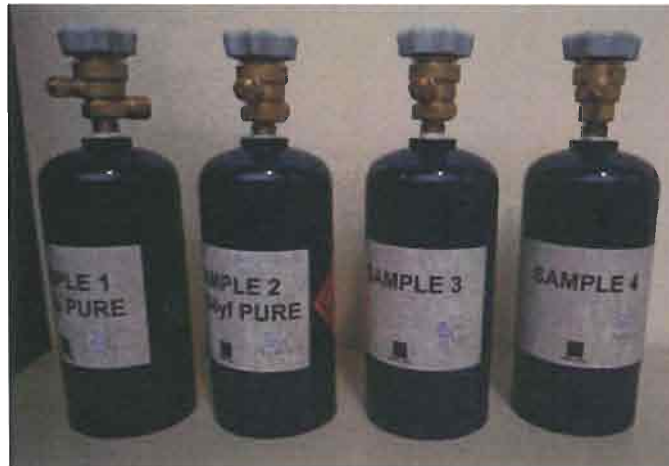
- Shipment of the samples to the pH srl laboratory for the contamination analysis
