FORD – ED0550 Ford Gen 3

EZDown Instruction – Generation 3

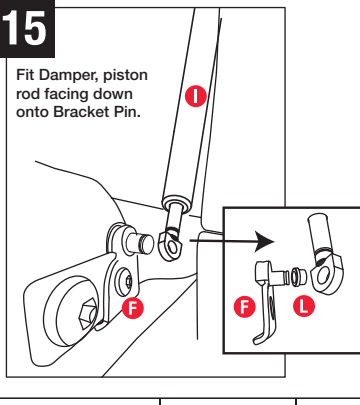
16 Confirm that the Damper has some movement in the tailgate open position therefore ensuring the cables are taking the tailgate weight and not the damper.
